**RE: Asbestos Survey
Memphis International Airport
Cargo Building #4 Roof
2491 Winchester Road
Memphis, TN 38118**

Asbestos Survey-Cargo Building #4 Roof

**2491 Winchester Road
Memphis, Shelby County, Tennessee**

Project No. 221425.00

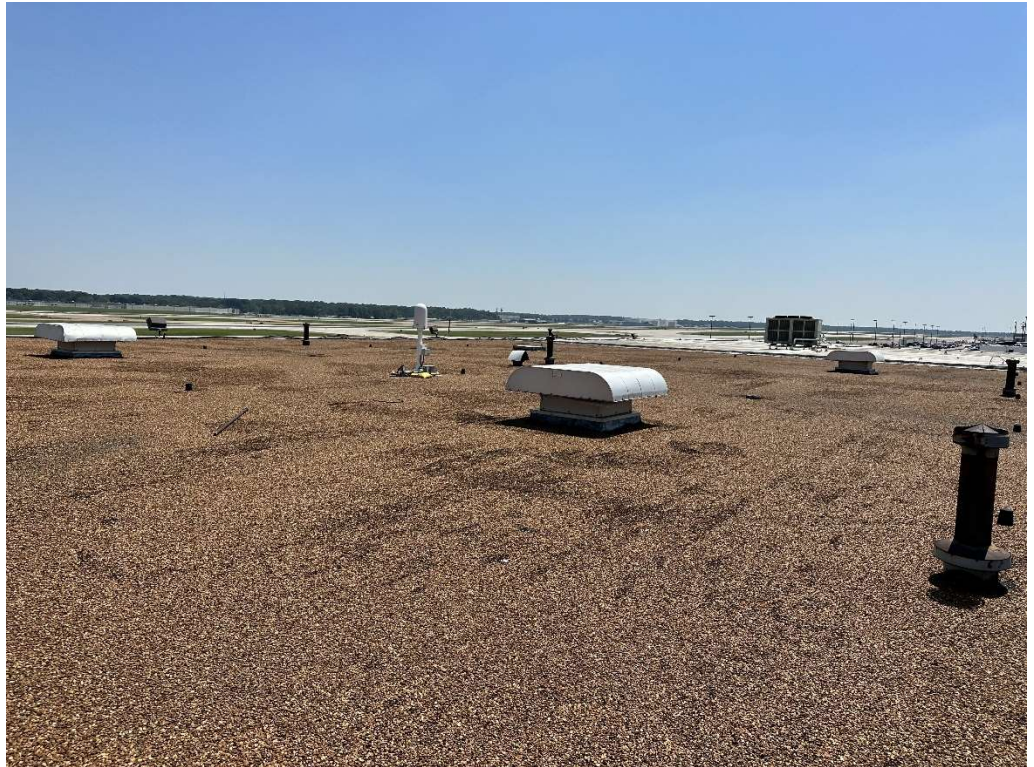
1

Overview of the roof of
Cargo Building #4

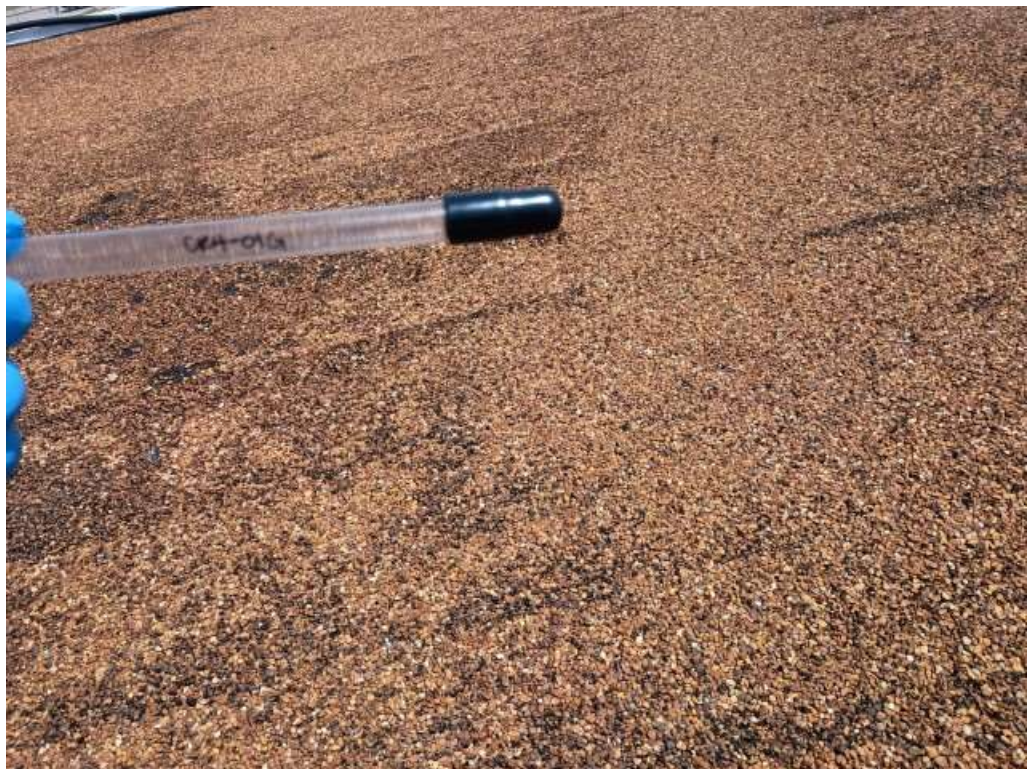
2

CR4-01: BUR Core

**Tested Positive for
Asbestos**

- The asbestos containing BUR Roofing, White Liquid Roof Patch, Gray Flashing, and Gray Rolled Roofing with Black Tar are non-friable Category I materials. The State of Tennessee and NESHAP require that non-friable ACM that could become friable during renovation activities must be removed prior to disturbance. Since these materials may be rendered friable during renovation activities, they must be removed by an asbestos abatement contractor prior to being disturbed by renovation activities. These materials can be disposed of at a landfill that accepts asbestos waste. Asbestos waste manifest should be kept for records.

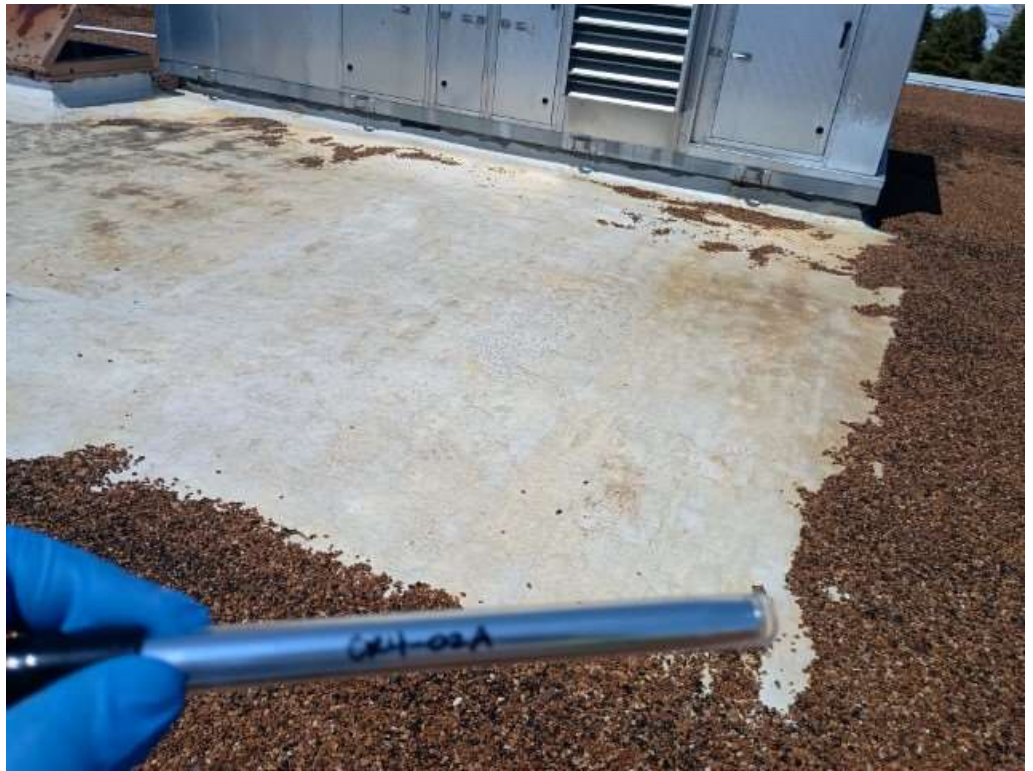
Photo #
3

CR4-02: White Liquid
Roof Patch

**Tested Positive for
Asbestos**

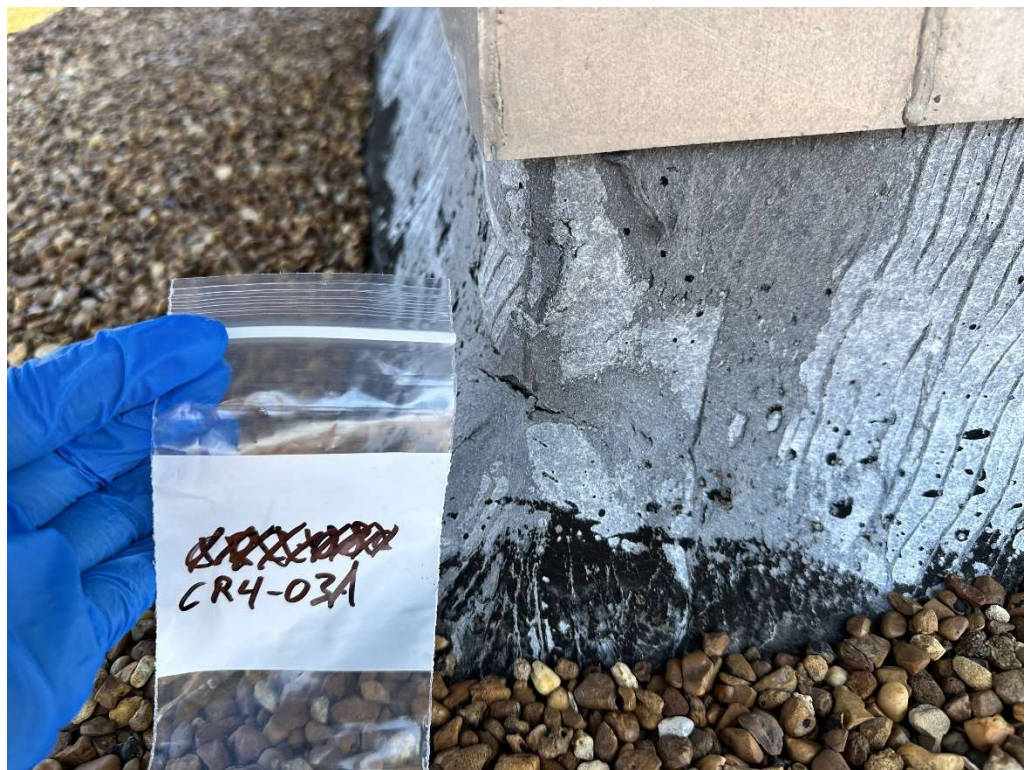
Photo #
4

CR4-03: Gray Flashing

**Tested Positive for
Asbestos**

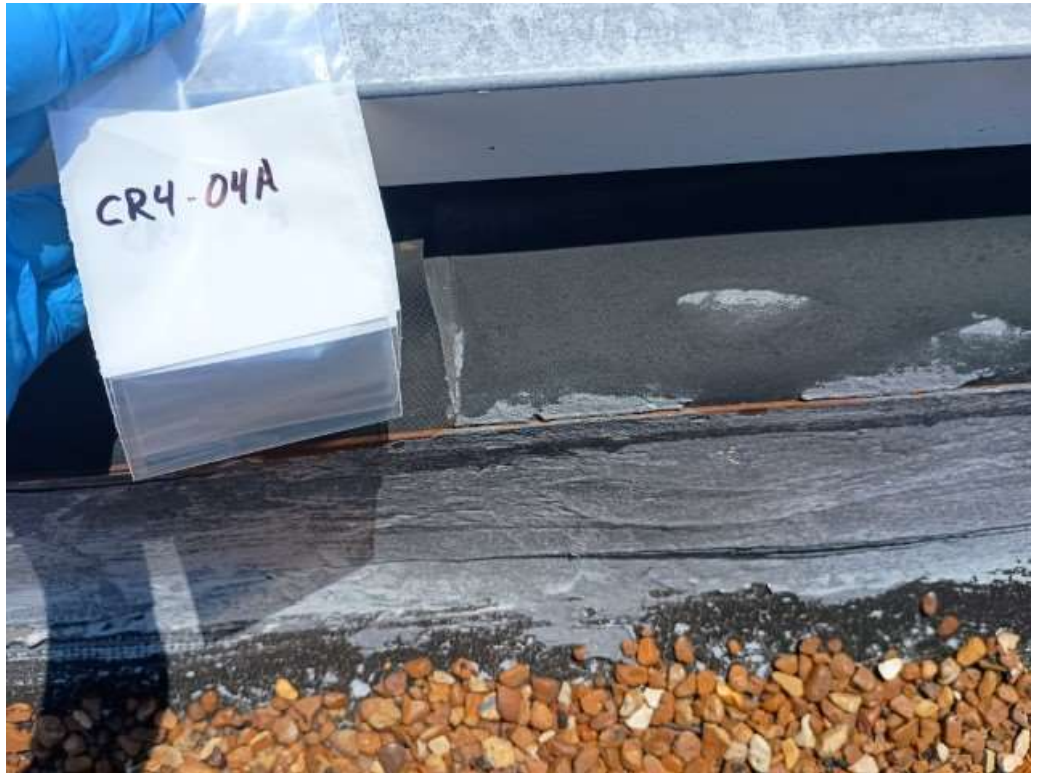
Photo #
5

CR4-04: Expansion
Joint

Tested Negative for
Asbestos

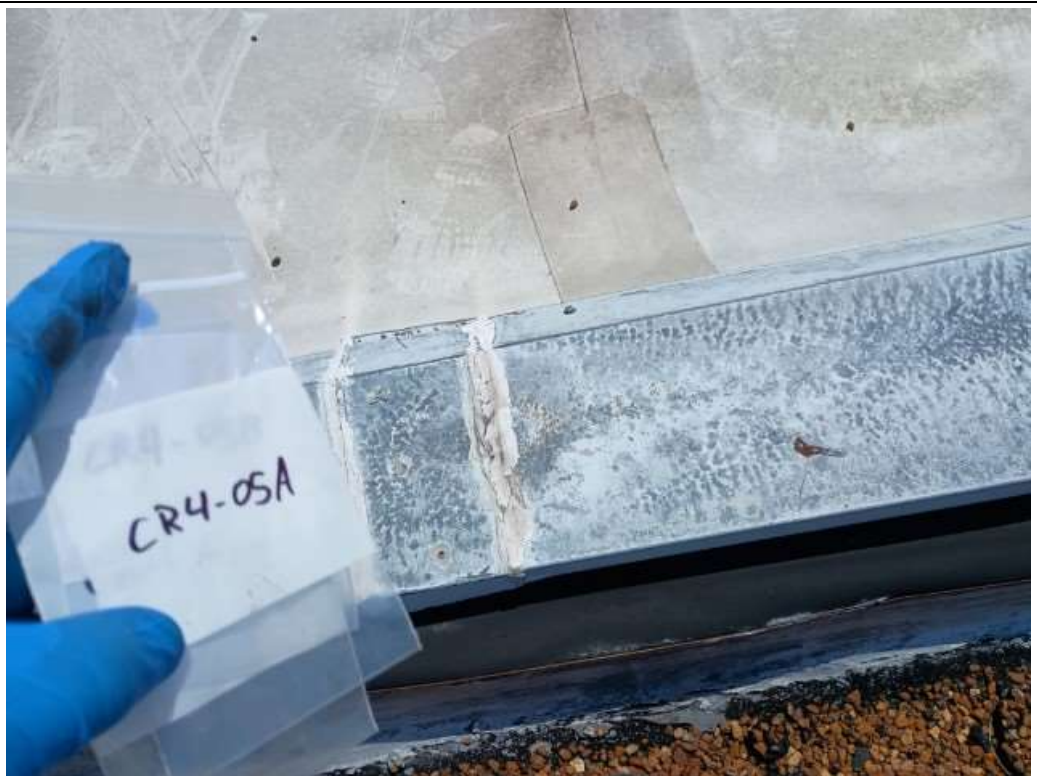
Photo #
6

CR4-05: White Parapet
Caulk

Tested Negative for
Asbestos

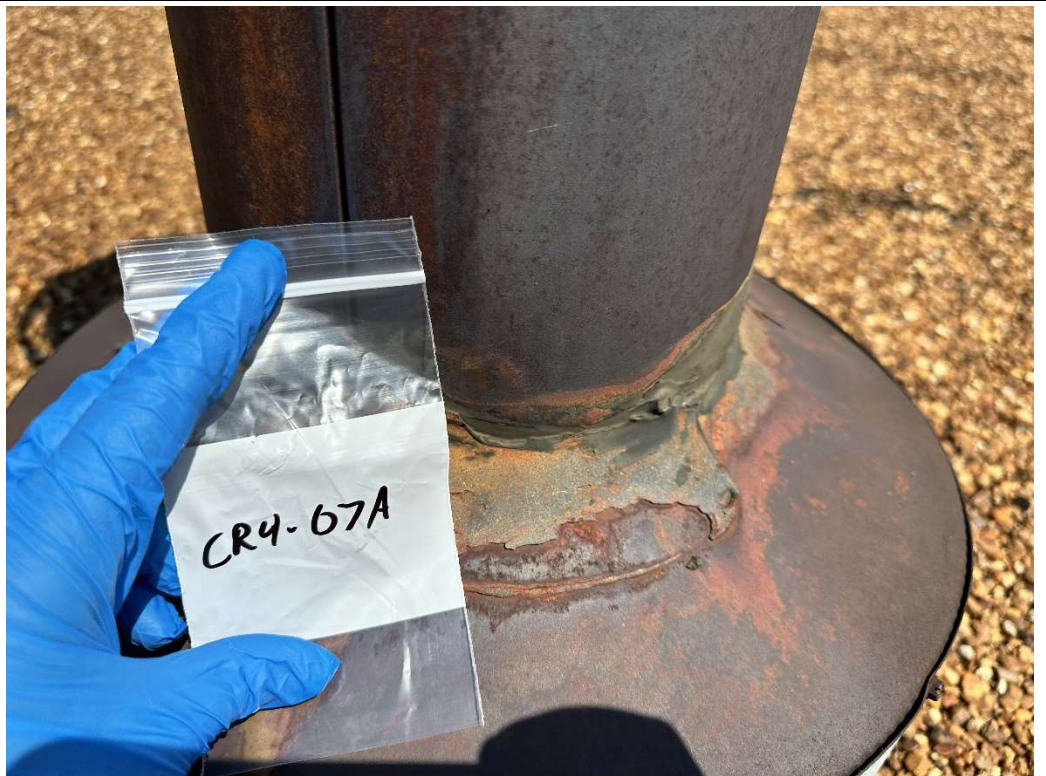
Photo #
8

CR4-07: Gray Seam
Caulk

Tested Positive for
Asbestos

- The asbestos containing Seam and Penetration Caulks are non-friable Category I materials as they are considered part of the roofing system. Since these materials may be rendered friable during renovation activities, they must be removed by an asbestos abatement contractor prior to being disturbed by renovation activities. These materials can be disposed of at a landfill that accepts asbestos waste. Asbestos waste manifest should be kept for records.

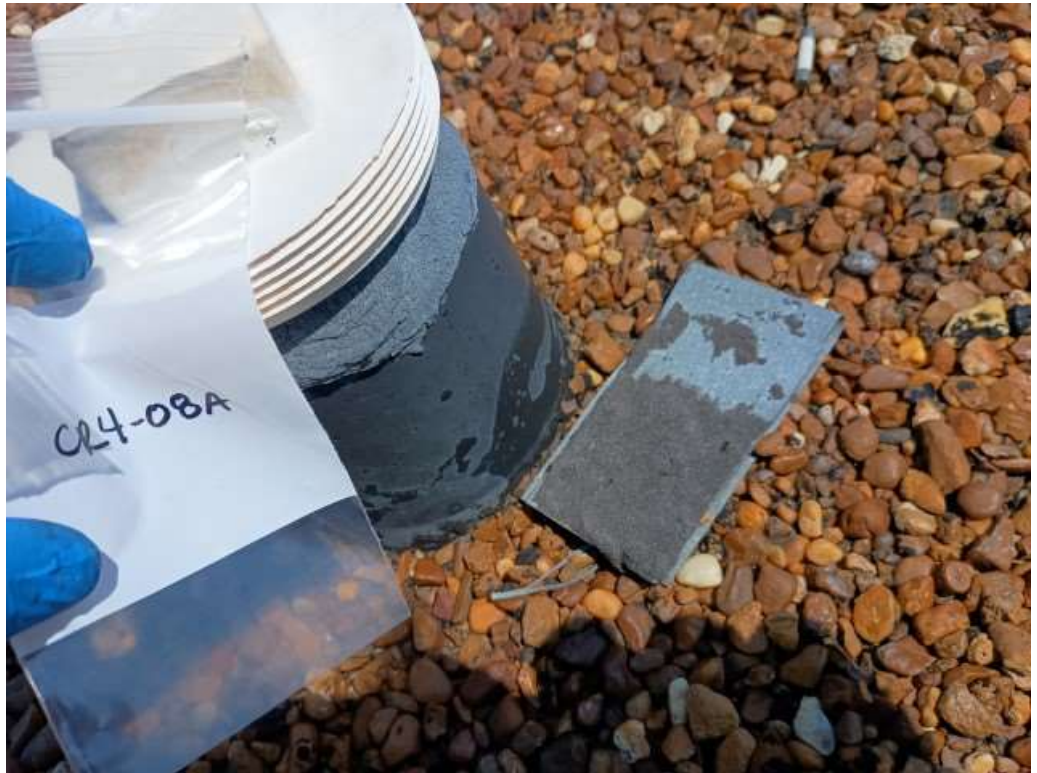
Photo #
9

CR4-08: Black
Penetration Caulk

Tested Positive for
Asbestos

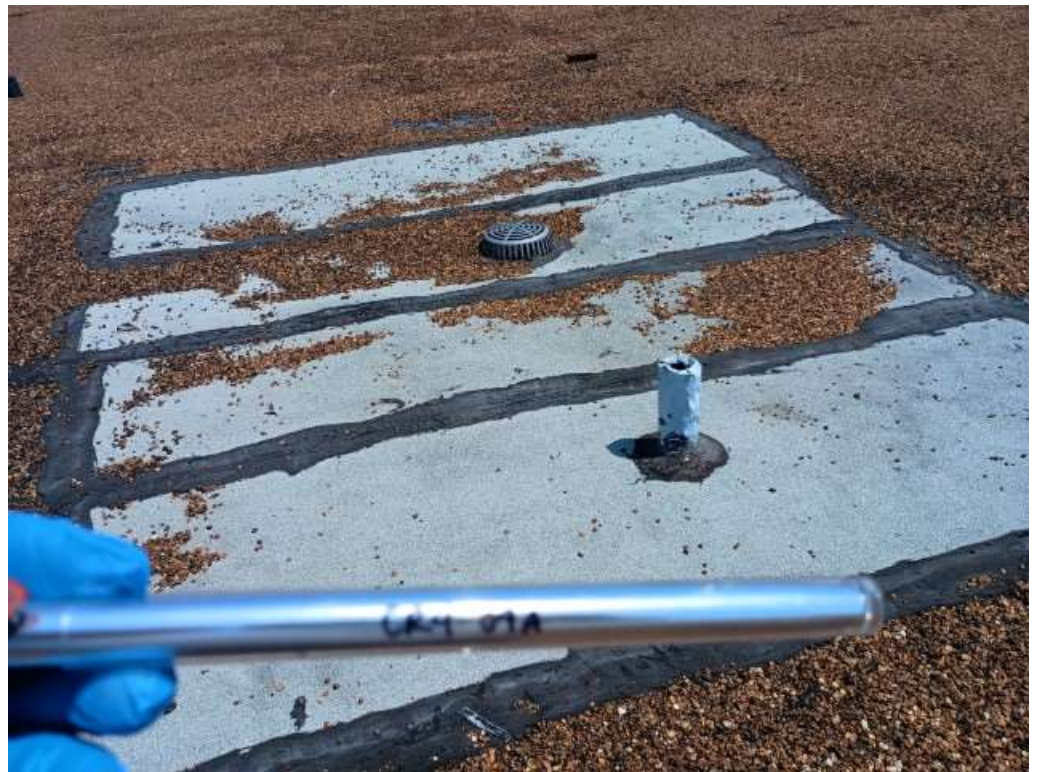
Photo #
10

CR4-09: Gray Rolled
Roofing with Black Tar

Tested Positive for
Asbestos

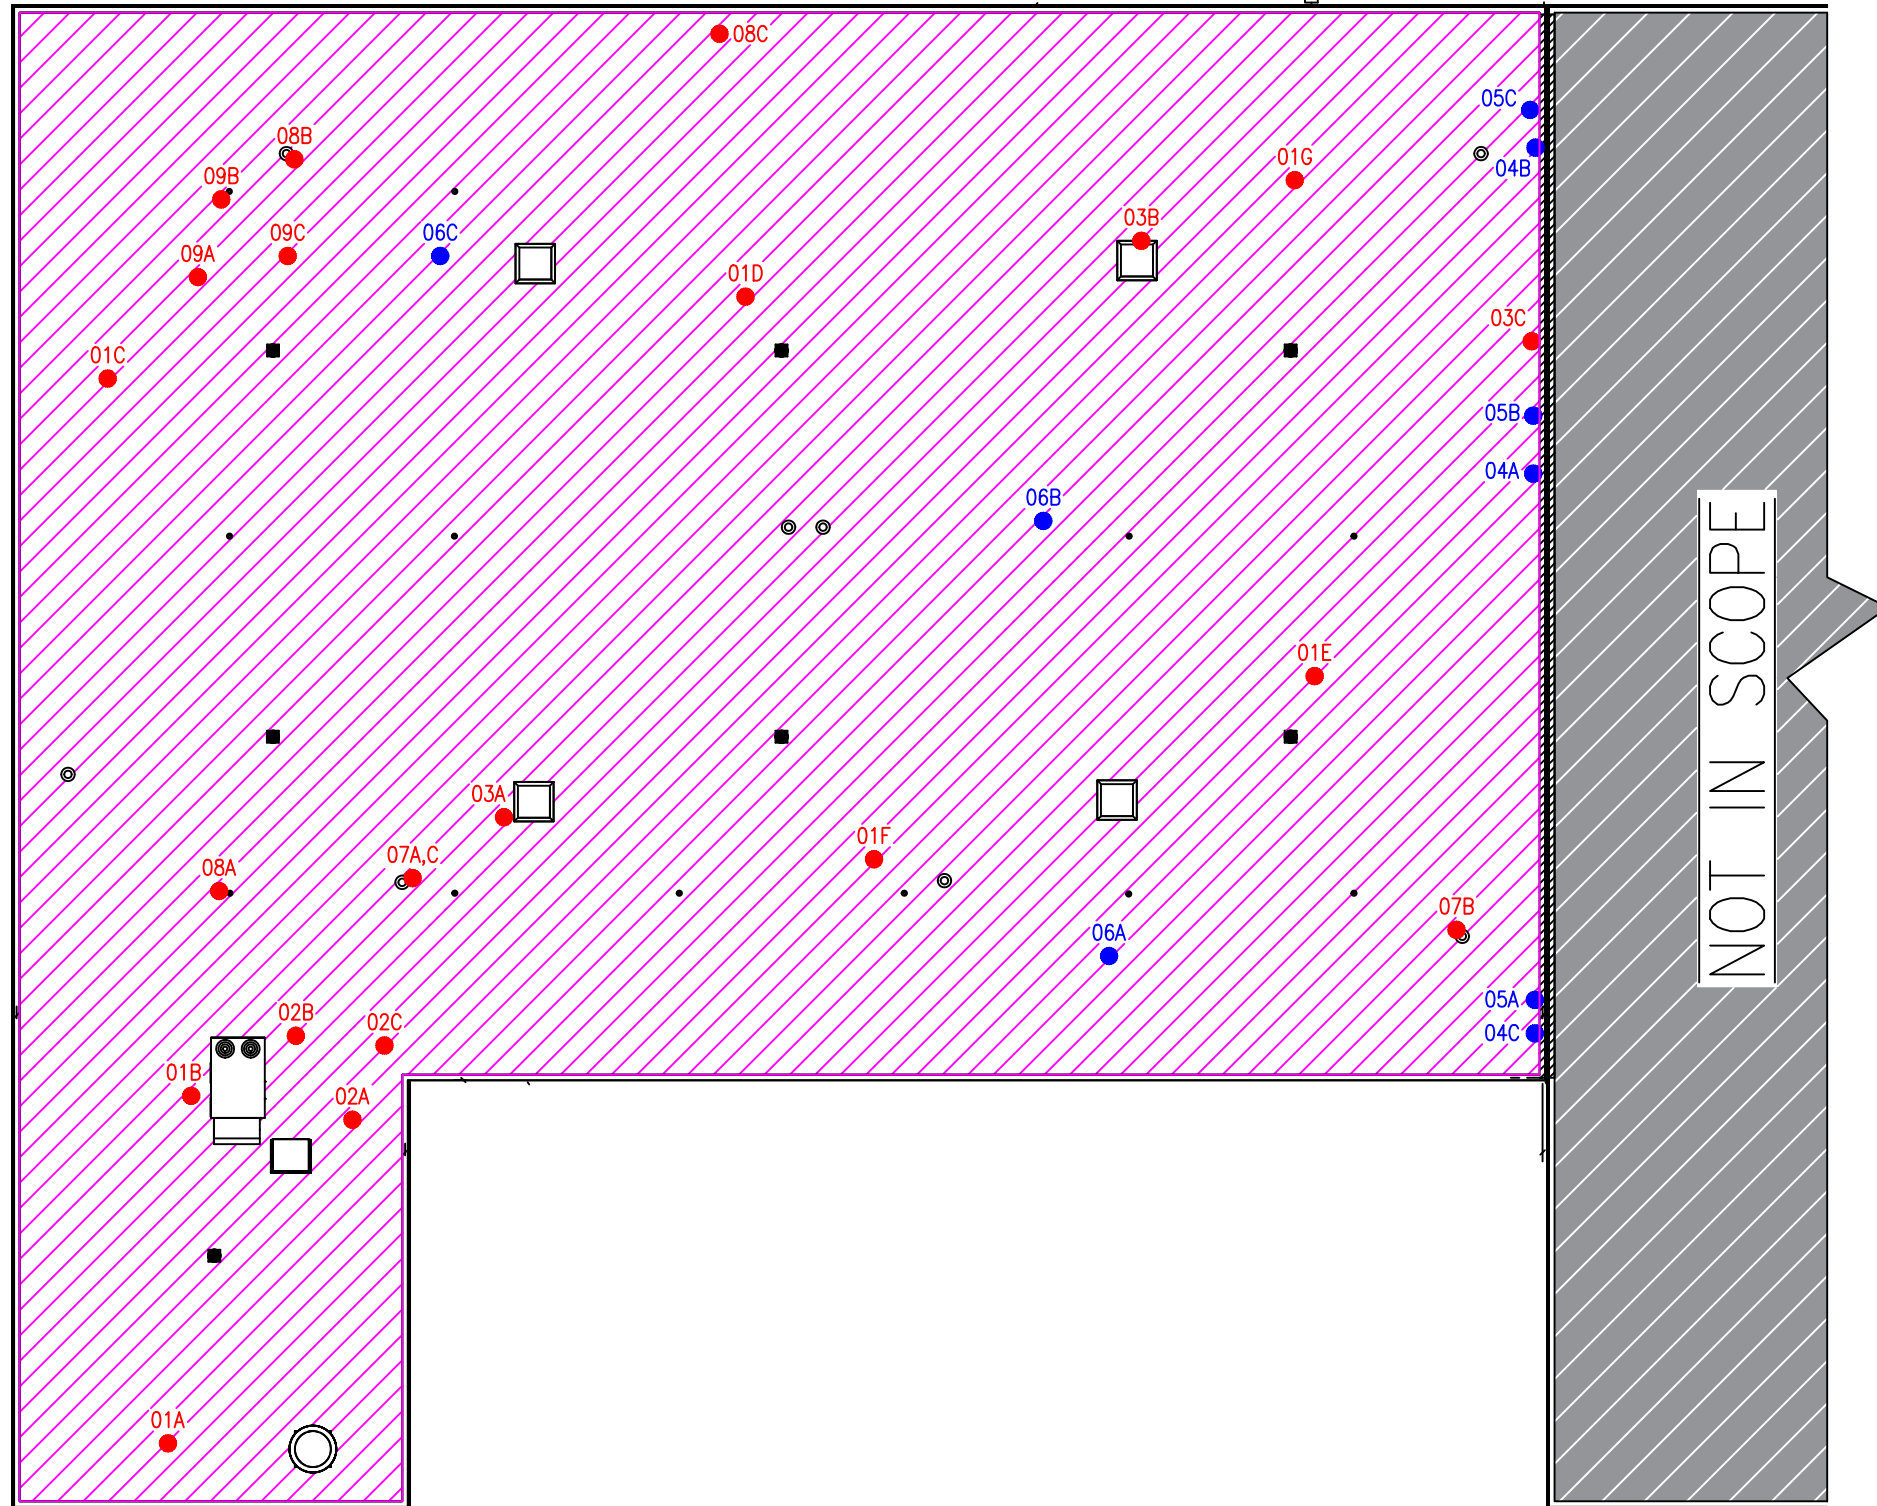
A drawing in Appendix 3 shows the sample locations and the locations of ACM at the Property.
