**RE: Asbestos Survey
Memphis International Airport
Cargo Building #2 Roof
2 Cargo Road
Memphis, TN 38116**

Asbestos Survey-Cargo Building #2 Roof

**2 Cargo Road
Memphis, Shelby County, Tennessee**

Project No. 221424.00

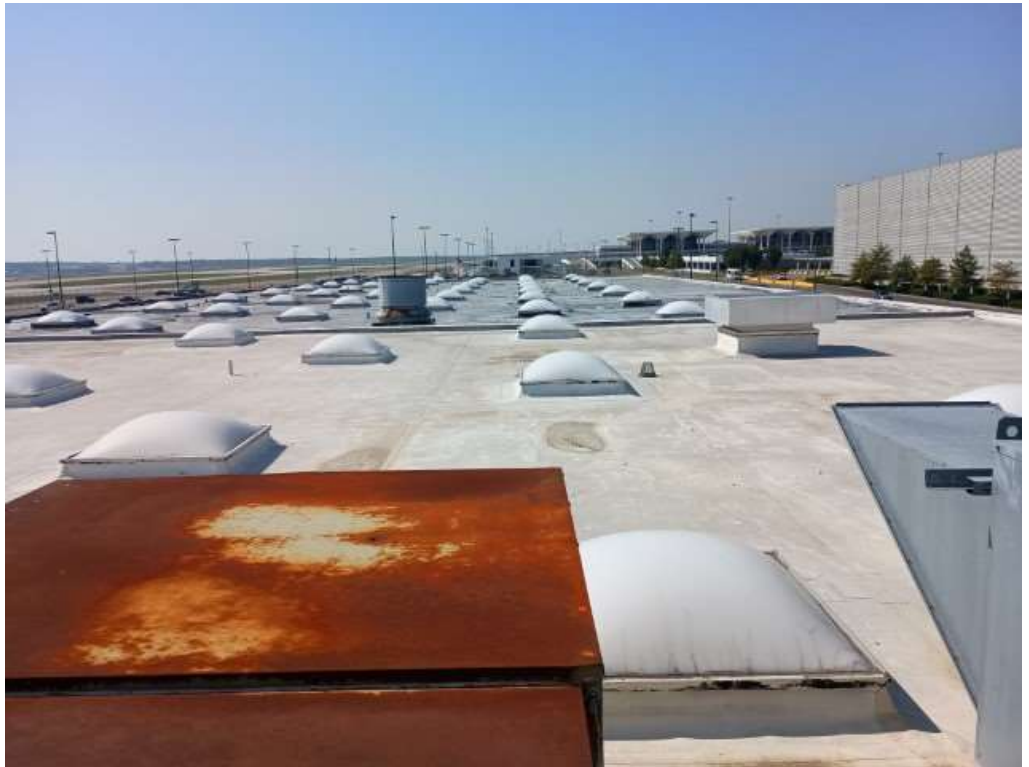
1

Overview of the roof of Cargo Building #2

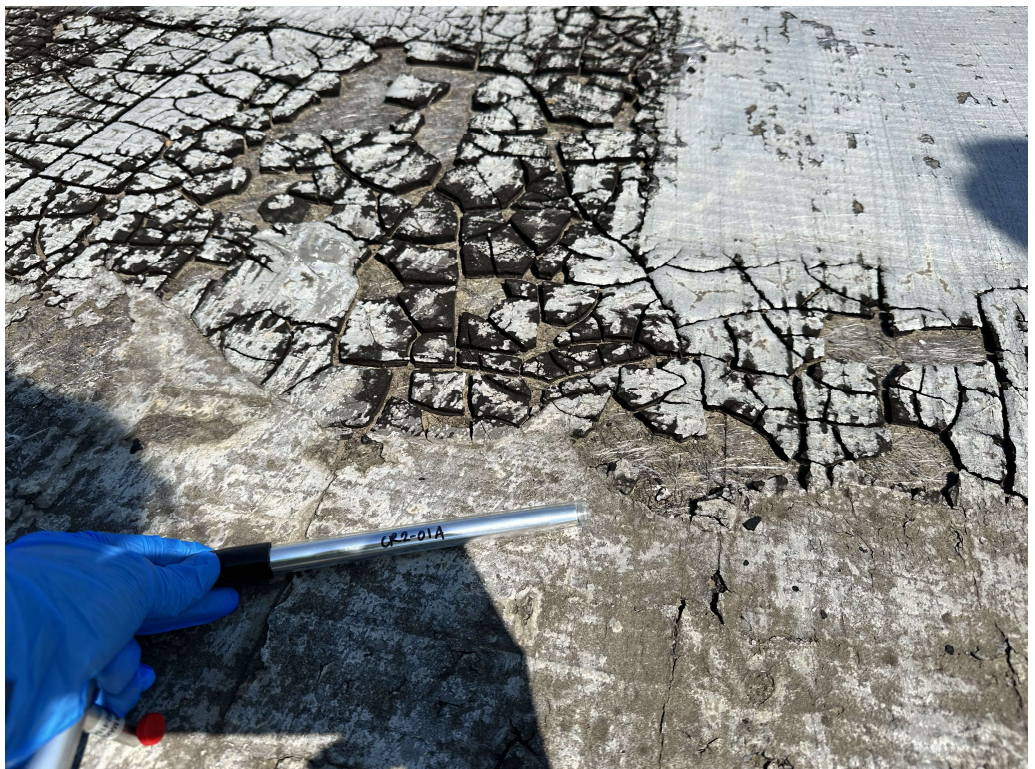
2

CR2-01: Silver Roofing

Tested Positive for Asbestos

- The asbestos containing Silver Roofing, Black Liquid Flashing, Black Fabric Flashing, and White TPO Roofing are non-friable Category I materials. The State of Tennessee and NESHAP require that non-friable ACM that could become friable during renovation activities must be removed prior to disturbance. Since these materials may be rendered friable during renovation activities, they must be removed by an asbestos abatement contractor prior to being disturbed by renovation activities. These materials can be disposed of at a landfill that accepts asbestos waste. Asbestos waste manifest should be kept for records.

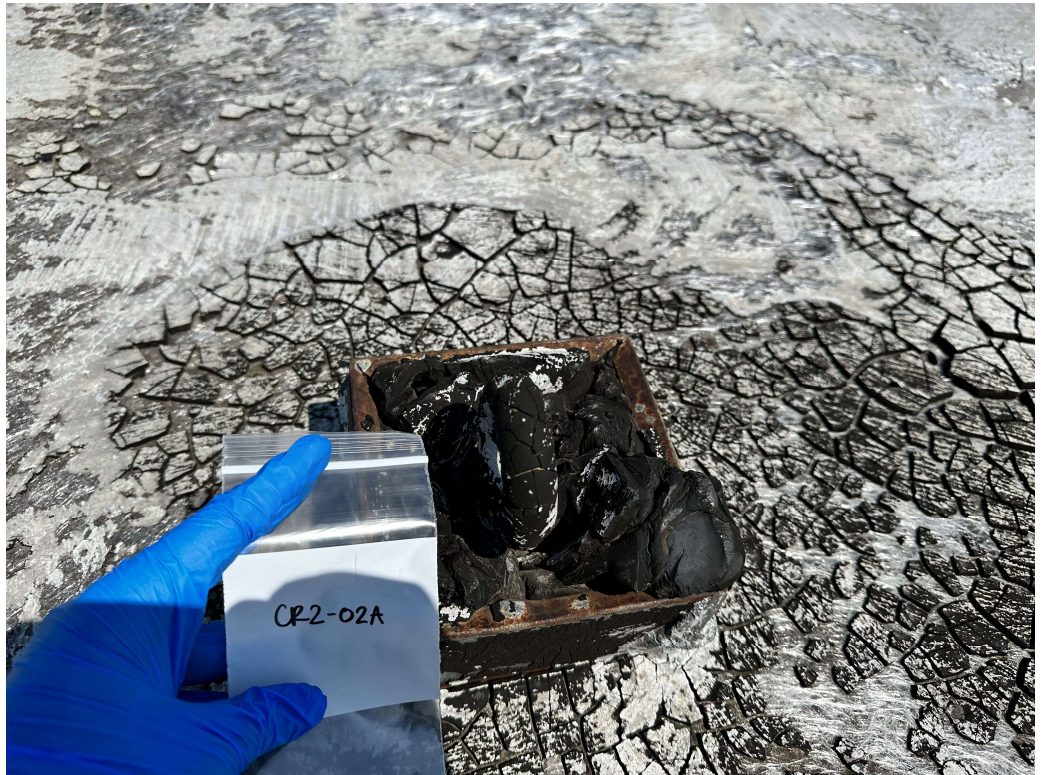
Photo #
3

CR2-02: Black Penetration Caulk

Tested Positive for Asbestos

- The asbestos containing White Skylight Caulk and Black Penetration Caulks are non-friable Category I materials as they are considered part of the roofing system. Since these materials may be rendered friable during renovation activities, they must be removed by an asbestos abatement contractor prior to being disturbed by renovation activities. These materials can be disposed of at a landfill that accepts asbestos waste. Asbestos waste manifest should be kept for records.

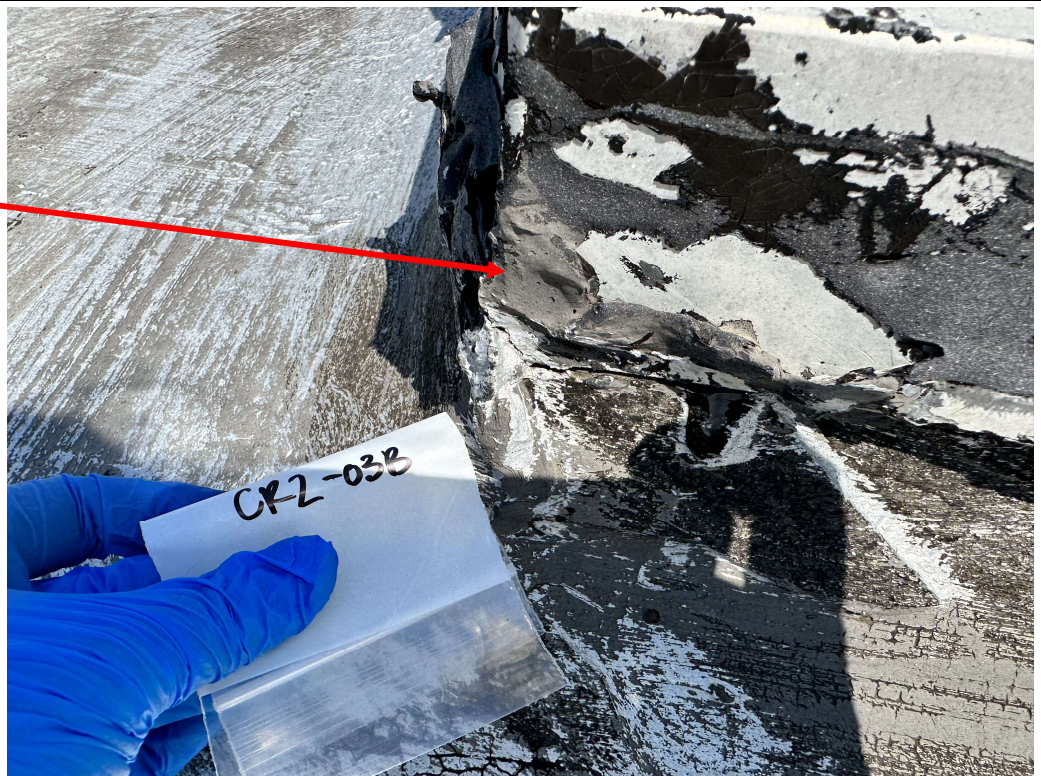
Photo #
4

CR2-03: Gray HVAC Caulk

Tested Positive for Asbestos

- The asbestos containing HVAC caulks are non-friable Category II materials as they are limited to the HVAC systems. Since these materials may be rendered friable during renovation activities, they must be removed by an asbestos abatement contractor prior to being disturbed by renovation activities. These materials can be disposed of at a landfill that accepts asbestos waste. Asbestos waste manifest should be kept for records.

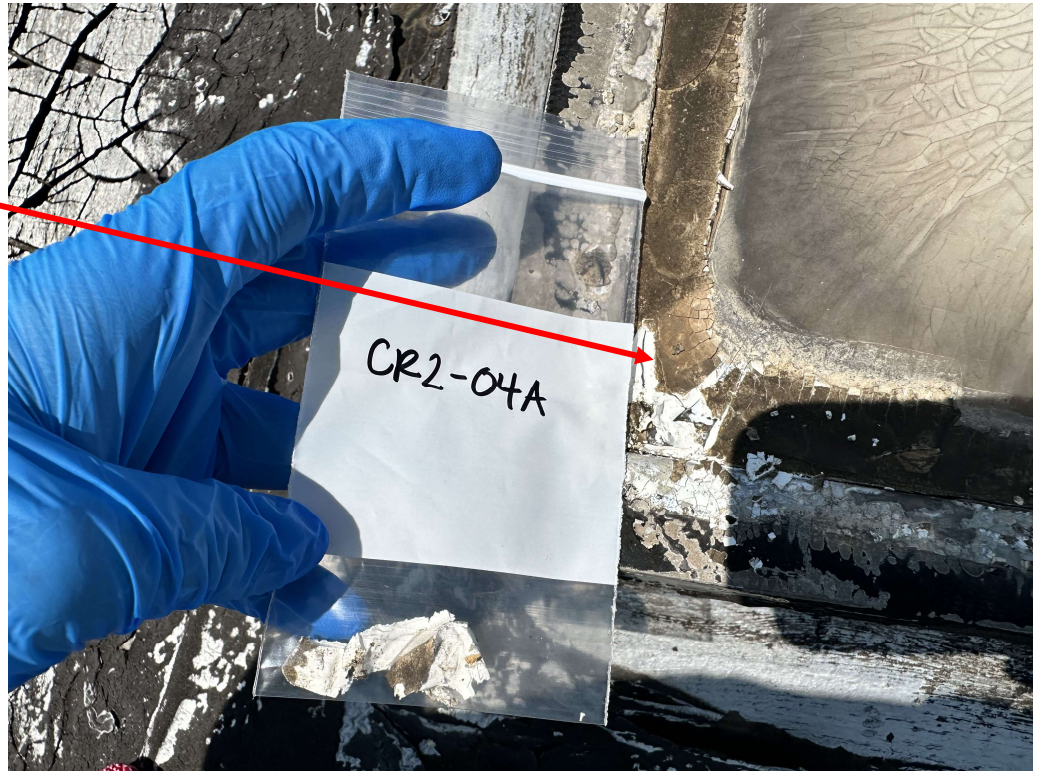
Photo #
5

CR2-04: White Skylight
Caulk

**Tested Positive for
Asbestos**

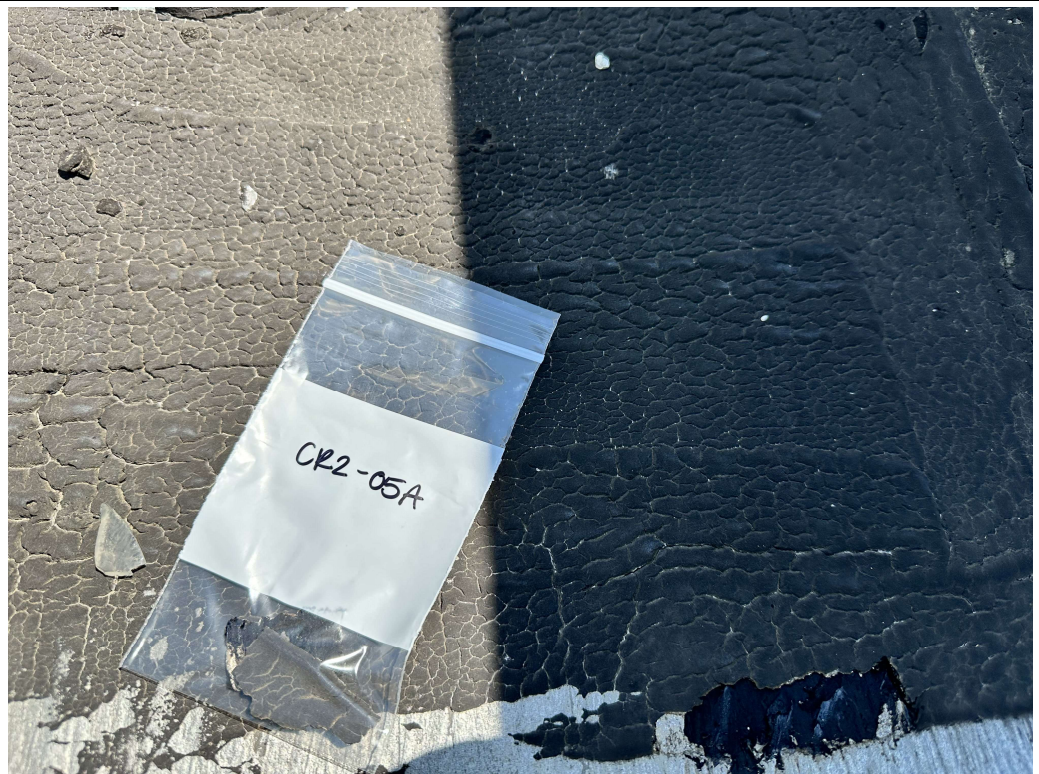
Photo #
6

CR2-05: Black Liquid
Flashing

**Tested Positive for
Asbestos**

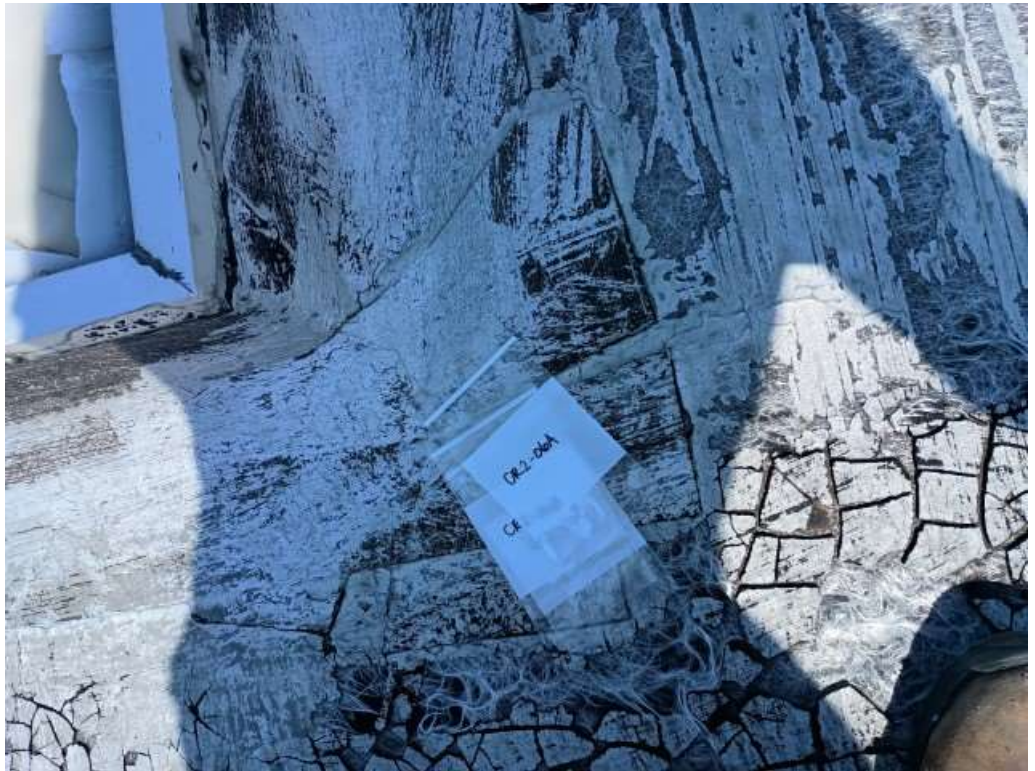
Photo #
7

CR2-06: Black Fabric Flashing

Tested Positive for Asbestos

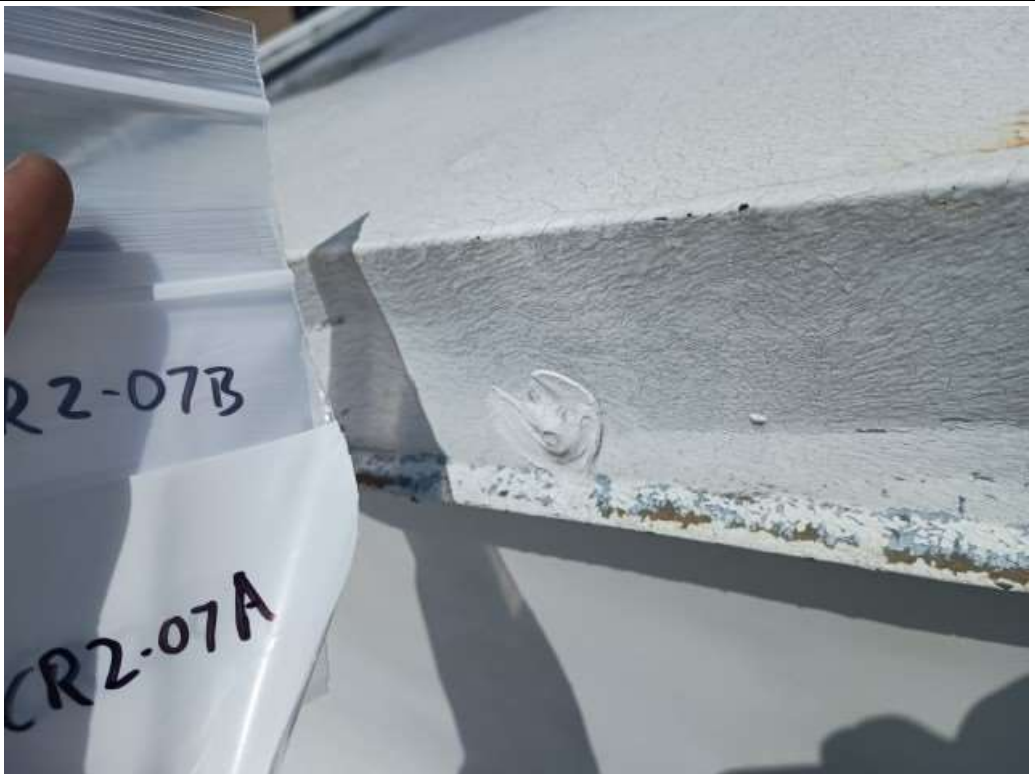
Photo #
8

CR2-07: White Parapet Caulk

Tested Negative for Asbestos

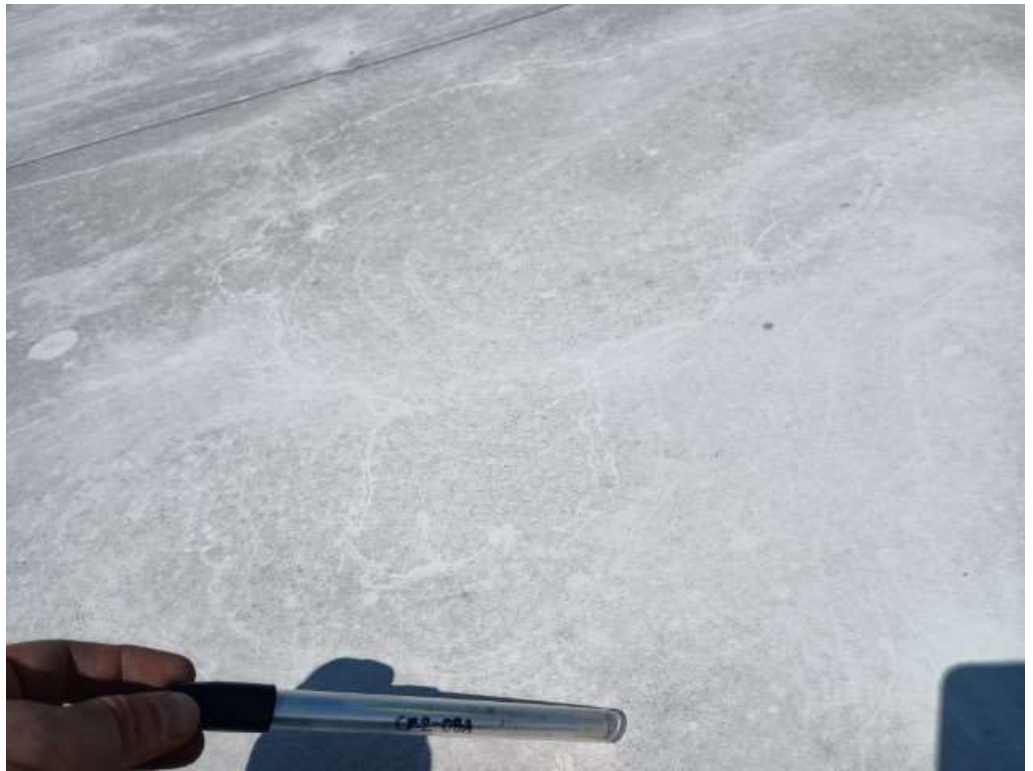
Photo #
9

CR2-08: White TPO Roofing

Tested Positive for Asbestos

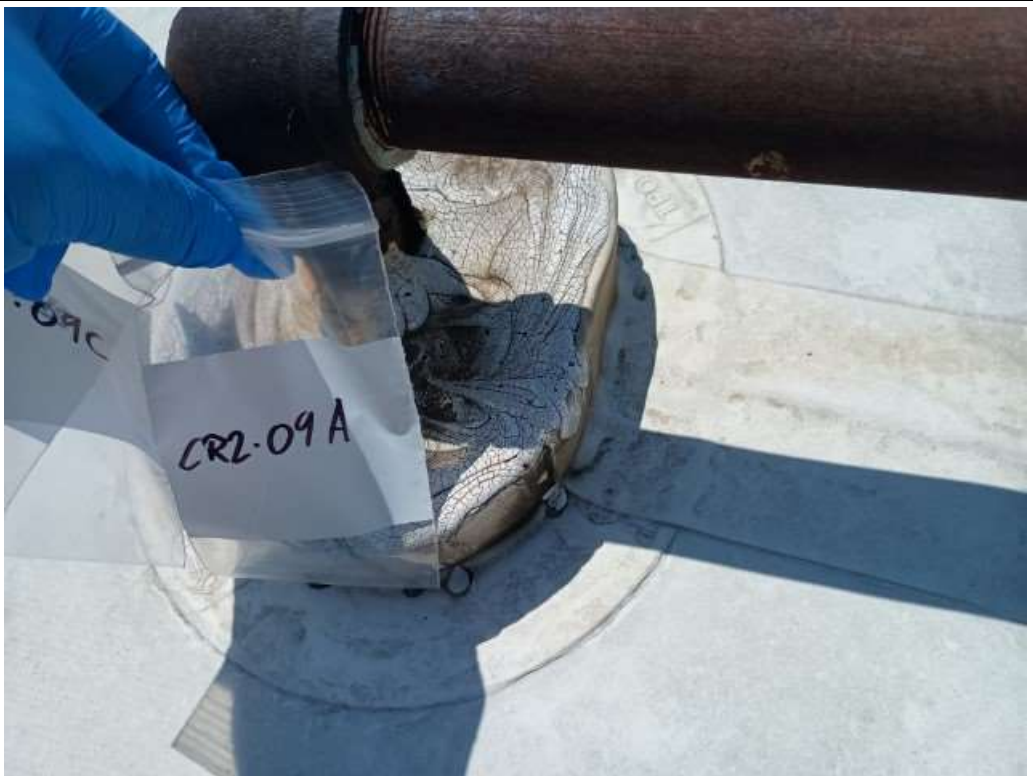
Photo #
10

CR2-09: White Penetration Caulk

Tested Negative for Asbestos

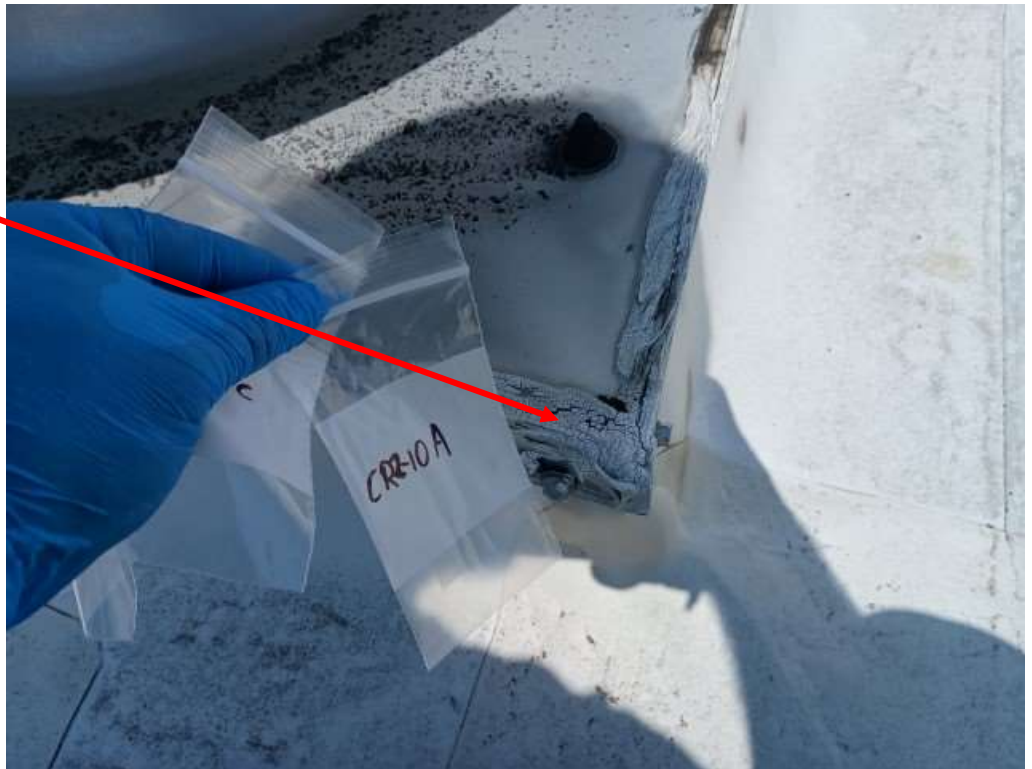
Photo #
11

CR2-10: White HVAC Caulk

Tested Positive for Asbestos

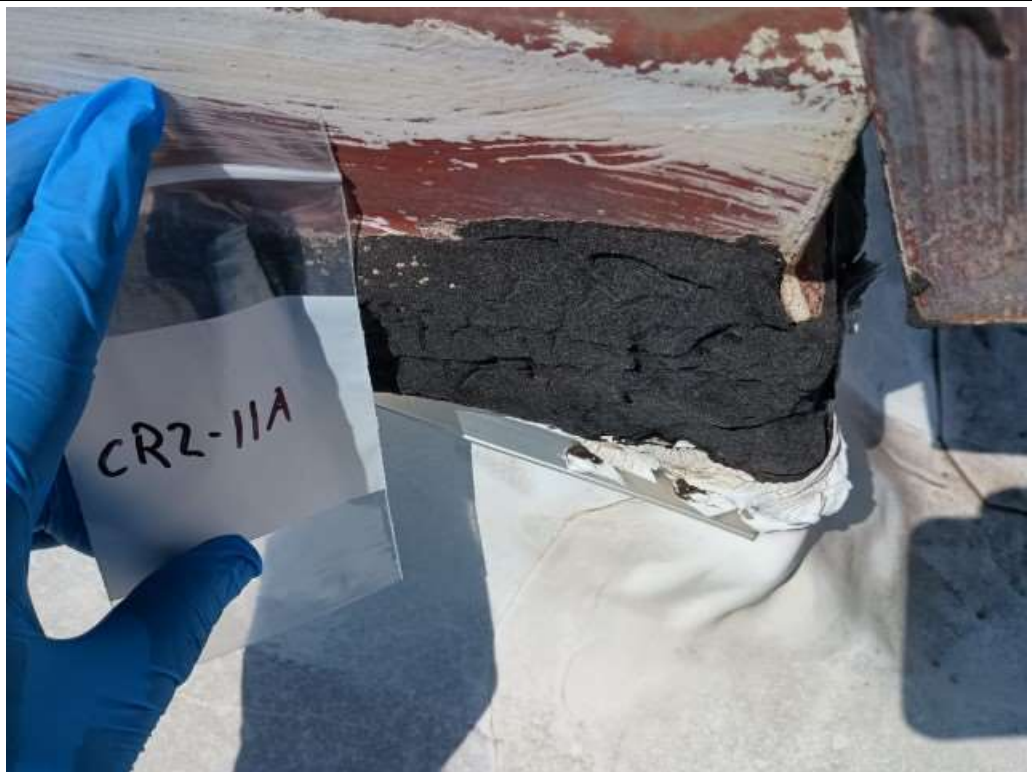
Photo #
12

CR2-11: Black Access Hatch Caulk

Tested Negative for Asbestos

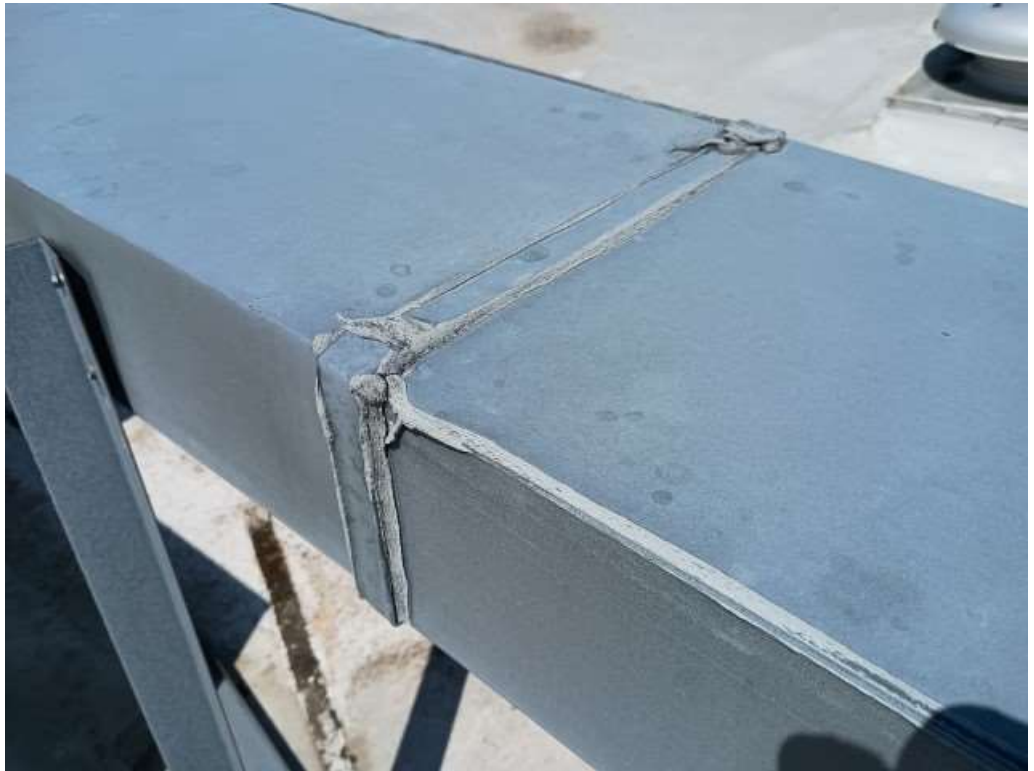
Photo #
13

CR2-12: Gray Duct Mastic

Tested Negative for Asbestos

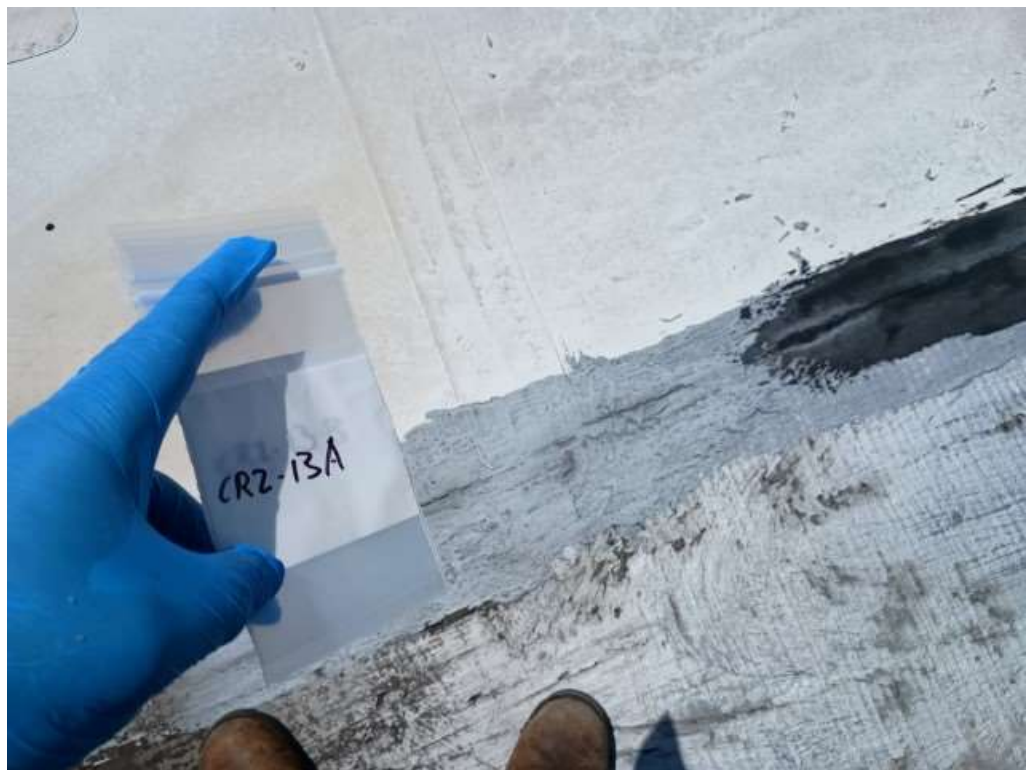
Photo #
14

CR2-13: Gray Liquid Flashing

Tested Negative for Asbestos

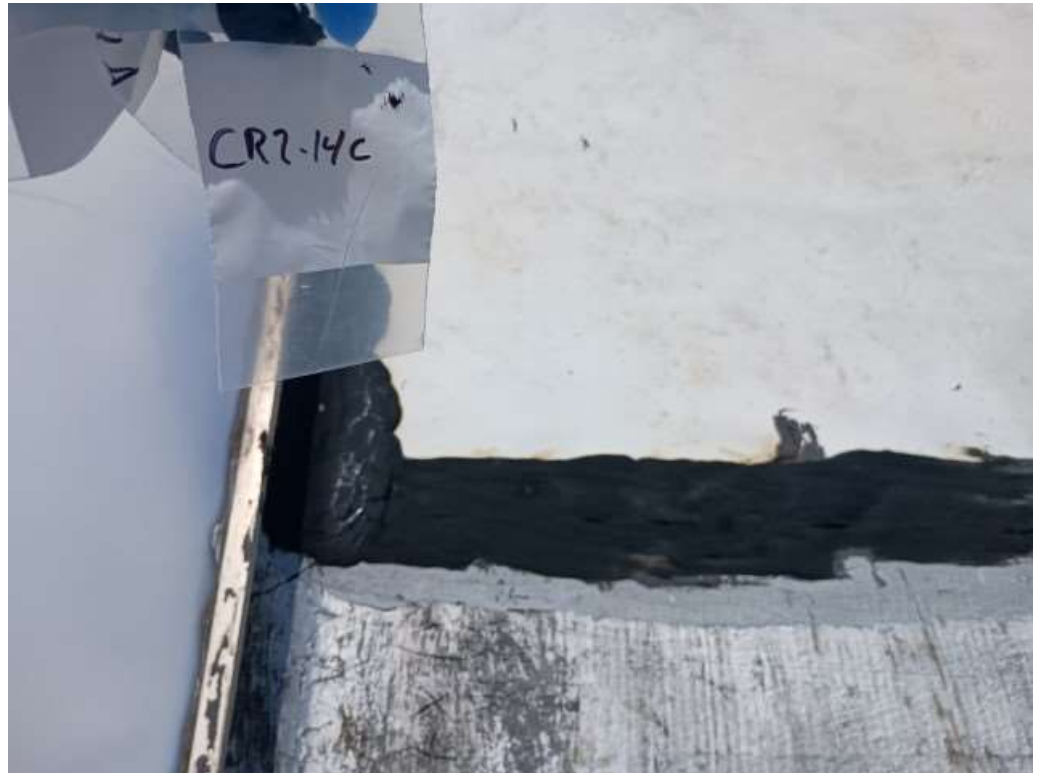
Photo #
15

CR2-14: Black Tar
Caulk

Tested Negative for
Asbestos

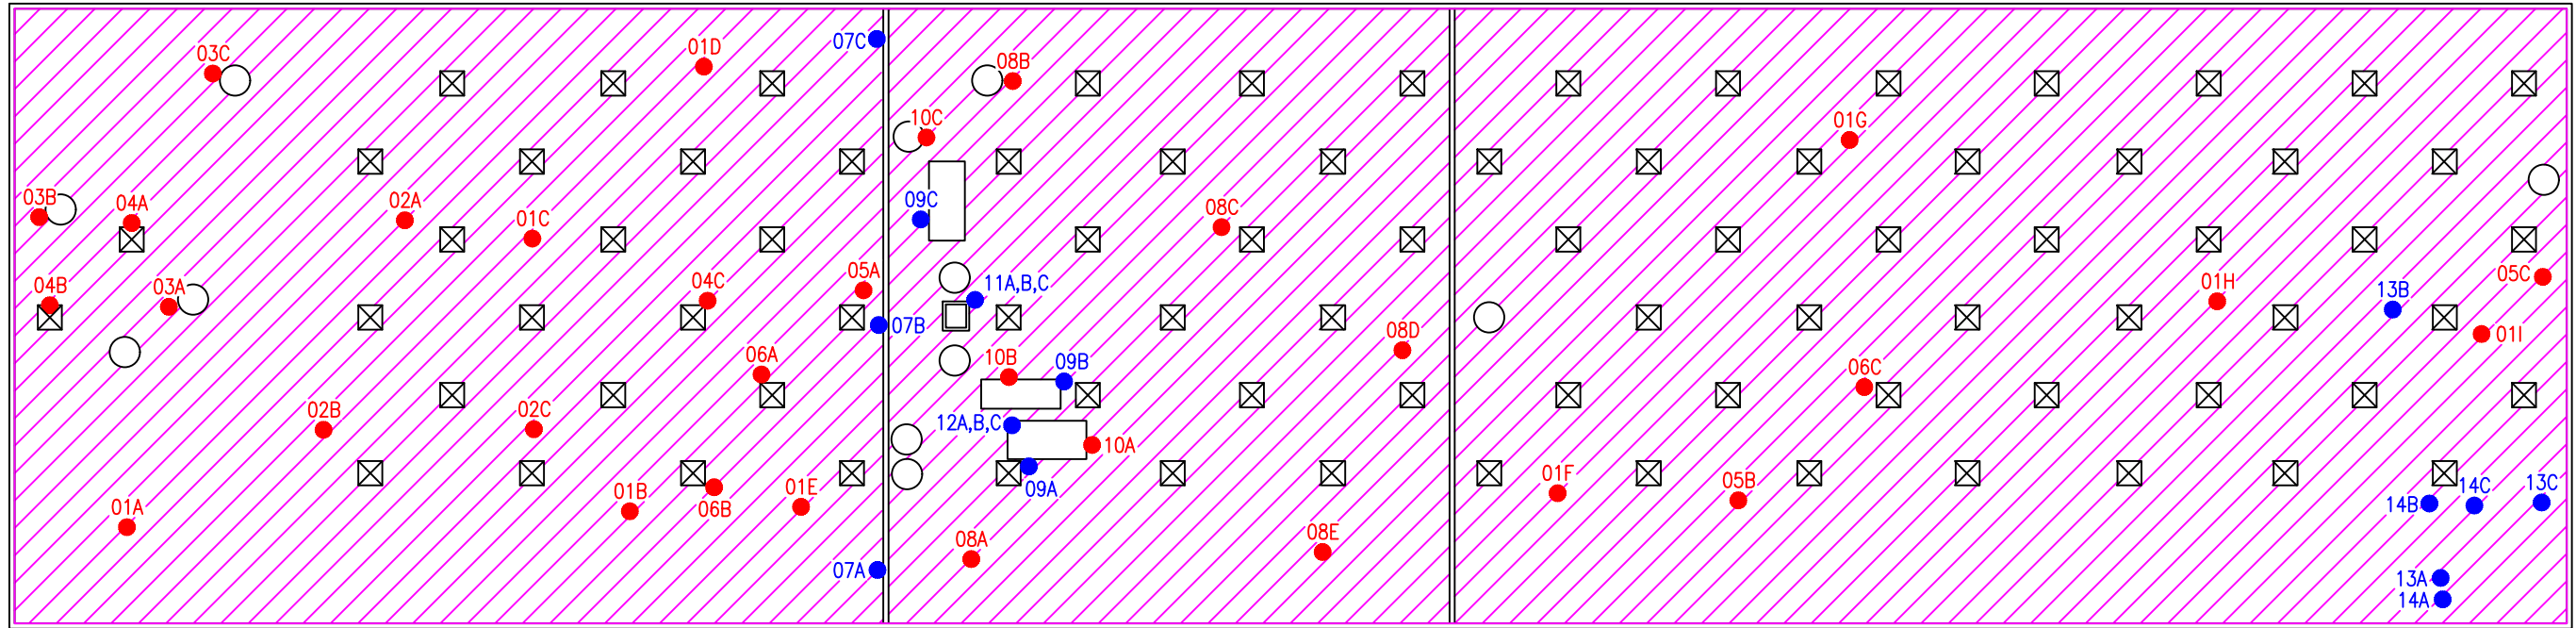
DESCRIPTION: ACM SAMPLE LOCATIONS
LOCATION: 2 CARGO RD, MEMPHIS, TN 38116
PROJECT #: 221424.00
DATE: SEPTEMBER 2023

Drawings in Appendix 3 show the sample locations and the locations of ACM at the Property.
