## MSCAA CARGO 4 BUILDING REROOF CARGO ROAD

Sheet Title:  
ROOF DETAILS

Project No:  
20008-T40

# A2.4

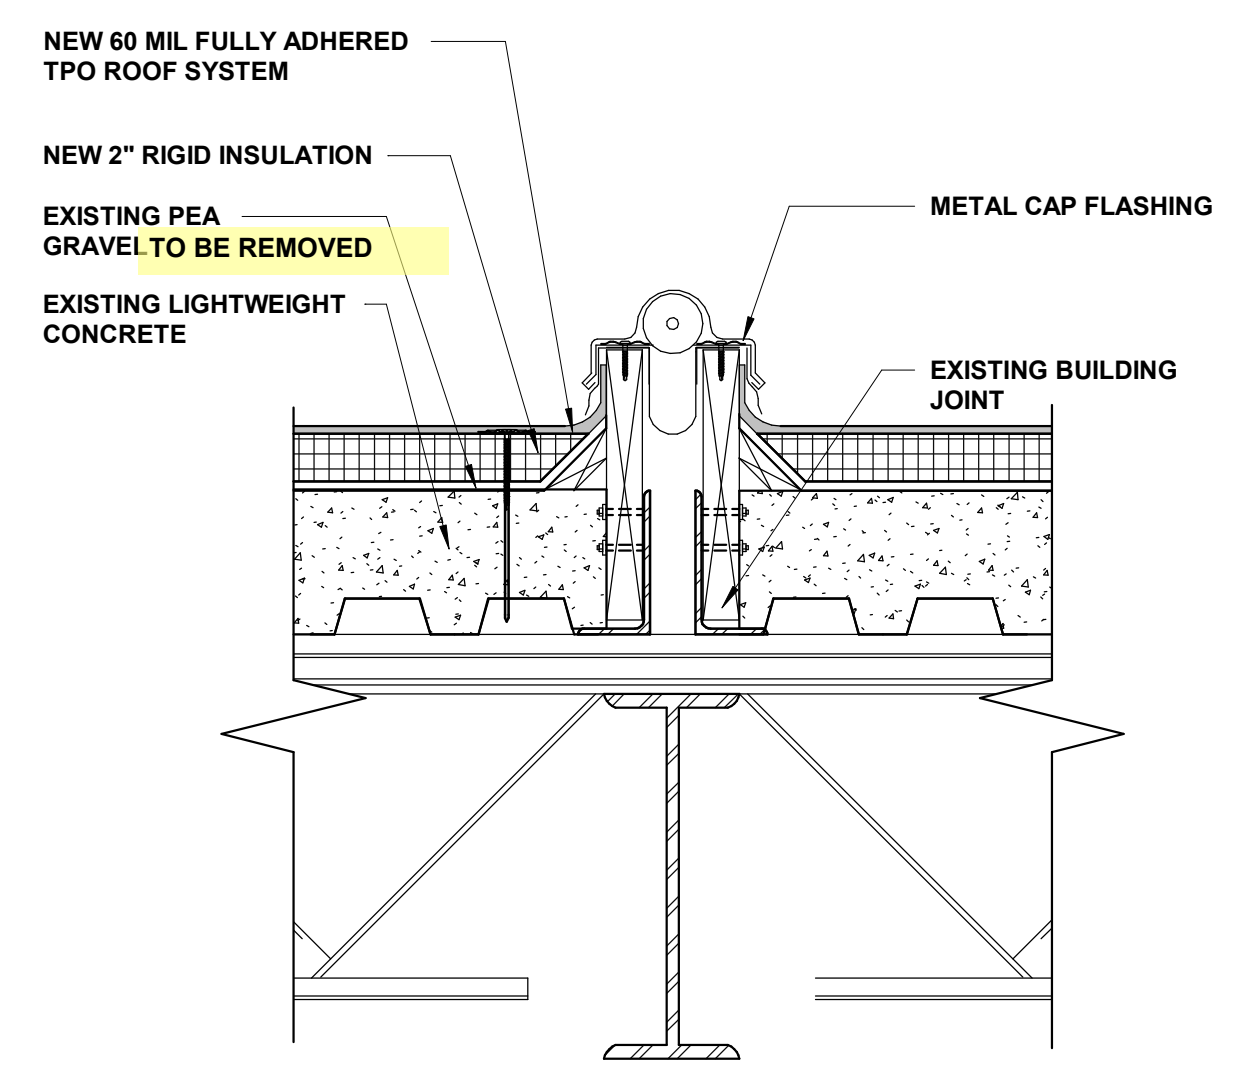
2 DETAIL @ ROOF EXPANSION JOINT  
1 1/2" = 1'-0"

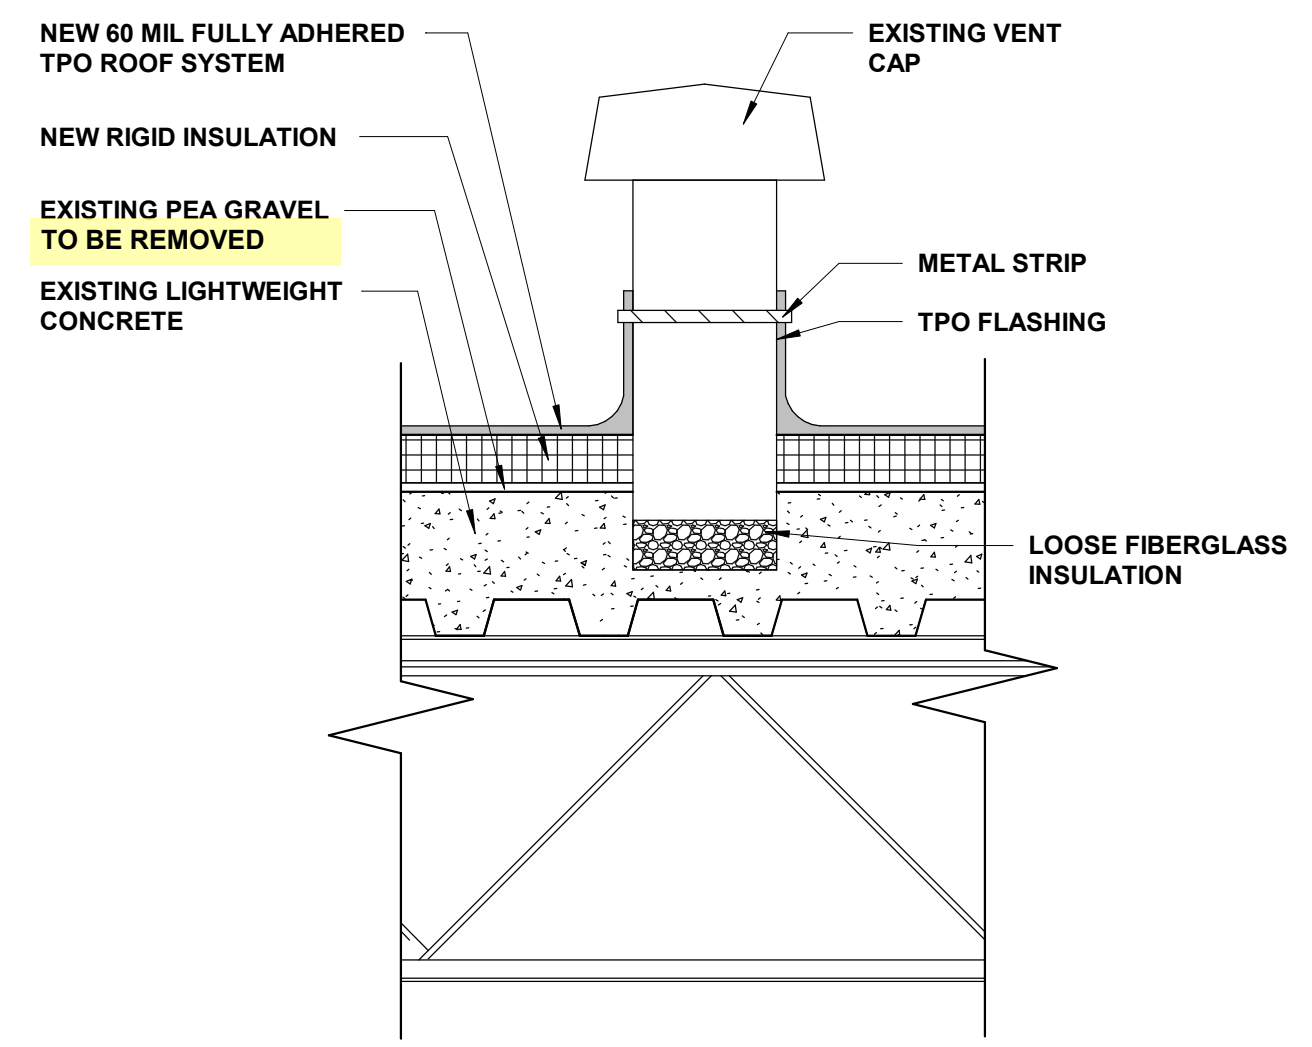
4 TYPICAL ROOF RELIEF VENT  
1 1/2" = 1'-0"

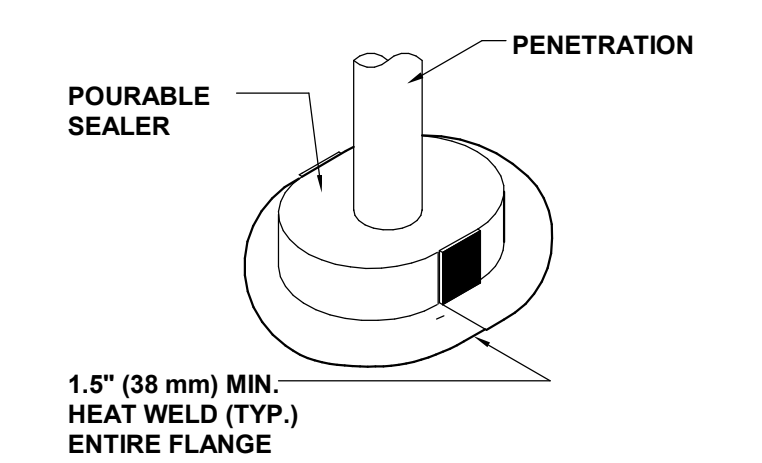
6 ROOF POCKET  
6" = 1'-0"

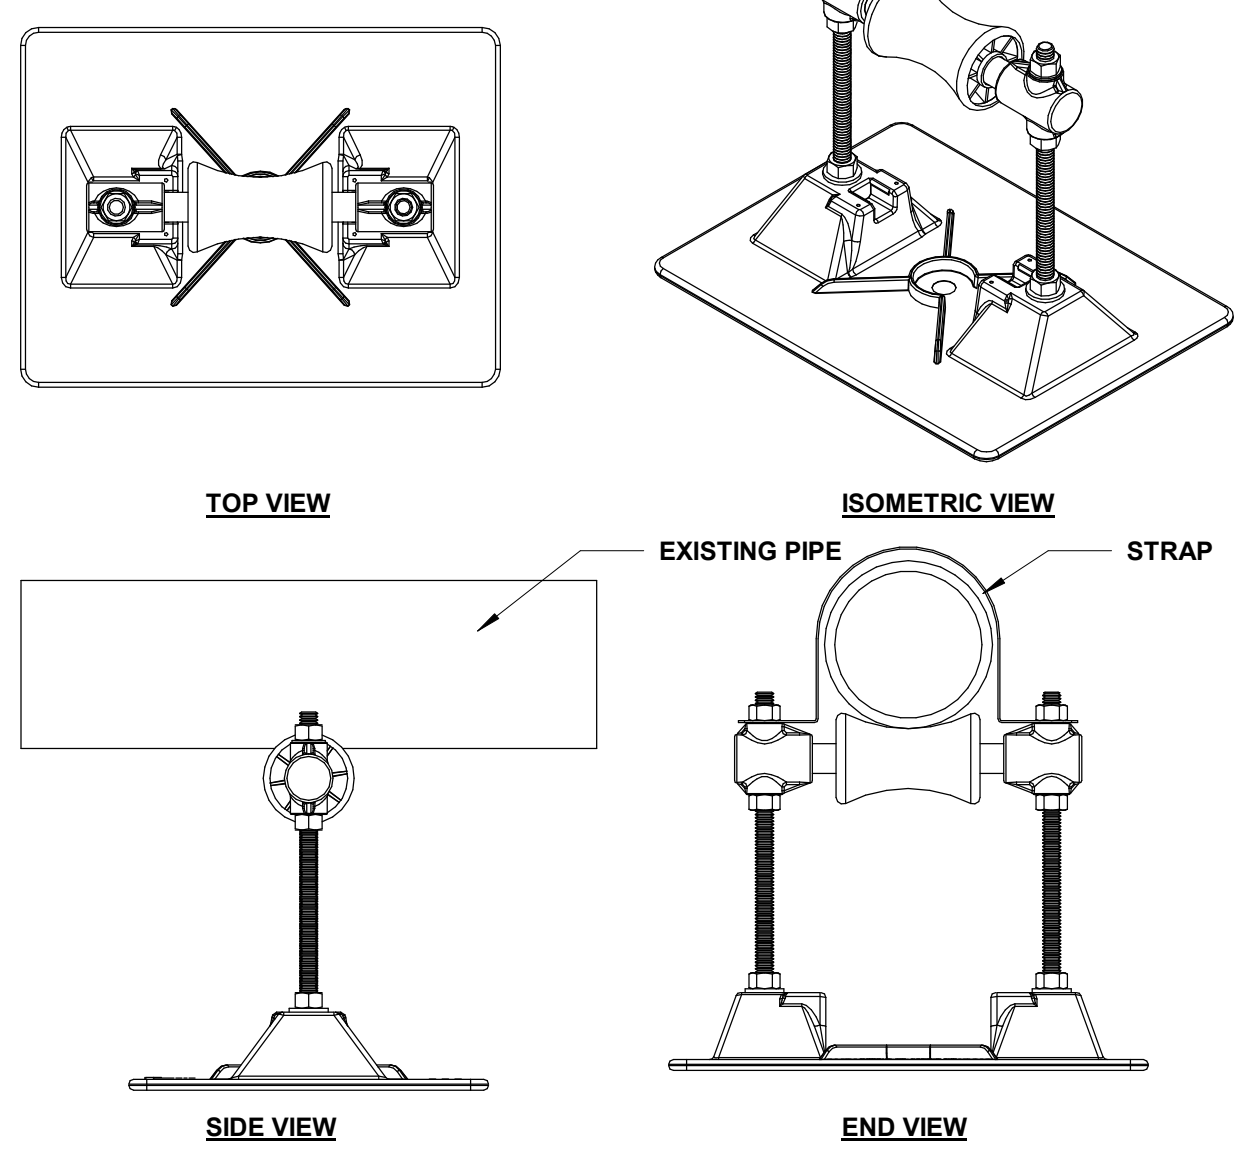
9 PIPE SUPPORT (TYP.)  
3" = 1'-0"

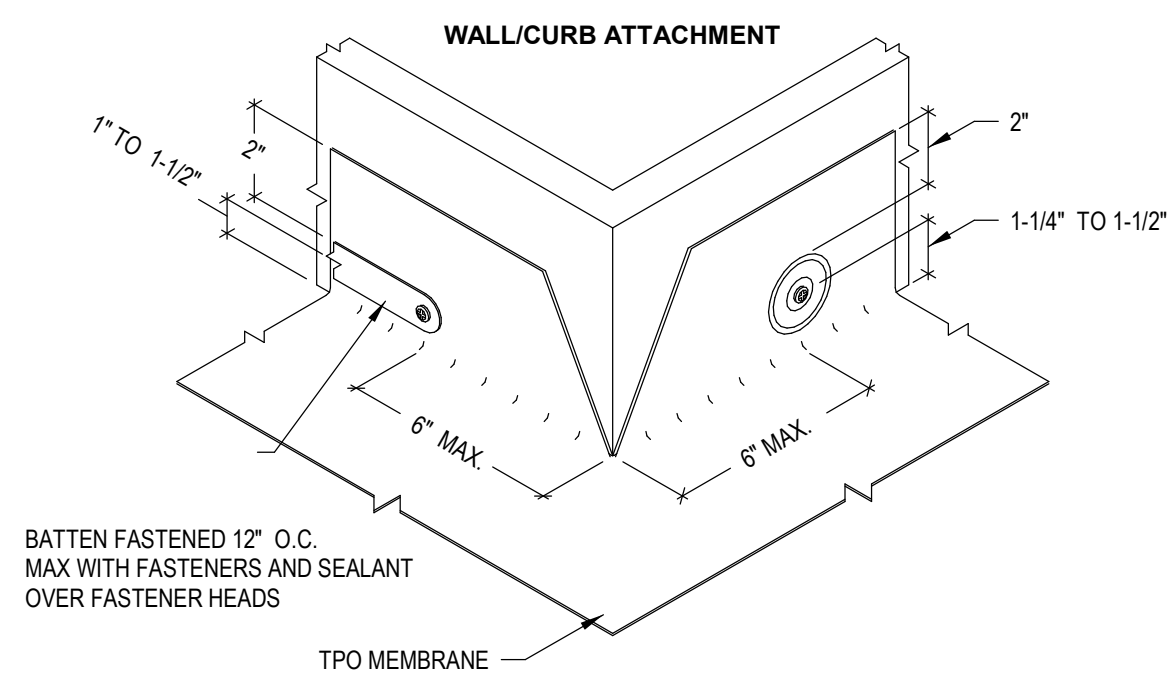
10 TPO @ OUTSIDE CORNER  
6" = 1'-0"
